Safeguard Home Inspection, Inc.
Presents Your Exclusive
HOME INSPECTION REPORT

(address deleted)
Marietta, GA 30064
October 16, 2011

Inspector: Rob Golden

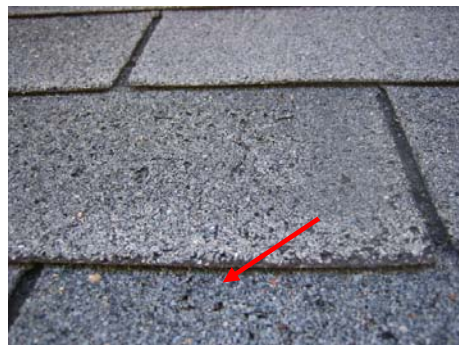
The roof shingles are relatively brittle and exhibiting a loss of granules which has caused pock-marks at the surface (SEE PHOTO). These conditions are typical of an aging roof and indicate a limited remaining service life. It is likely the roof will need replacement within the next five years.

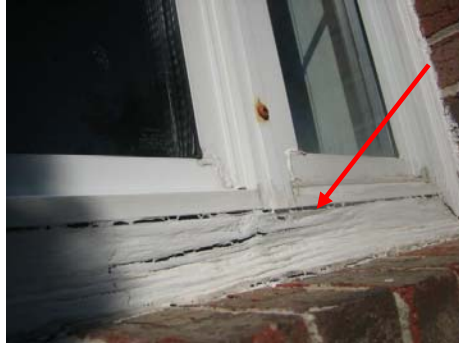
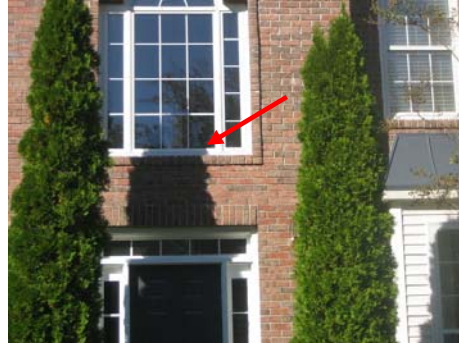
Wood rot is noted at the bottom of the window frame directly above the front door (SEE PHOTOS). Recommend replacement of damaged window frame.

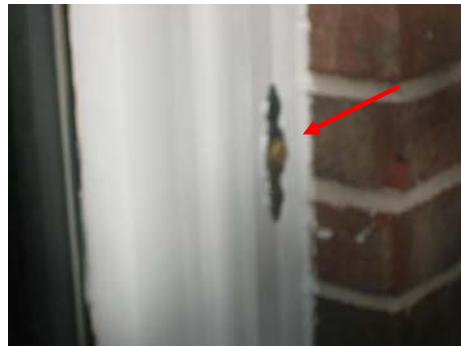
The door bell at the front entrance is not operational (SEE PHOTO). It cannot be determined if the failure is at the button itself or the indoor chime. Recommend repair or replacement of front door bell.

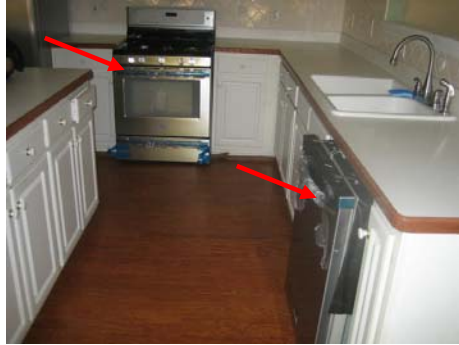
A new dishwasher and oven are present in the Kitchen but not installed to the utility lines and therefore not presently operational (SEE PHOTO). Recommend installation of the dishwasher and oven by a qualified appliance technician.

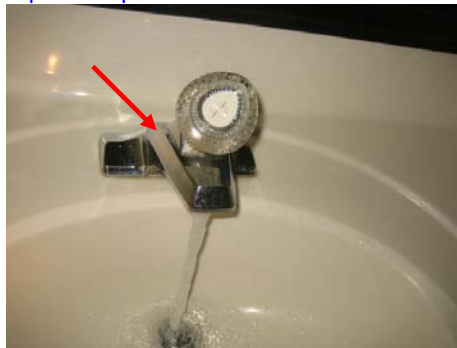
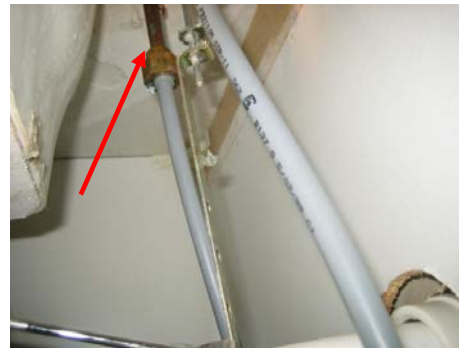
Water is noted dripping into the vanity cabinet beneath the sink in the First Floor Half Bathroom when the faucet is on (SEE PHOTOS). This condition appears to be due to an internal leak within the faucet itself. Recommend repair or replacement of sink faucet by a qualified plumber.

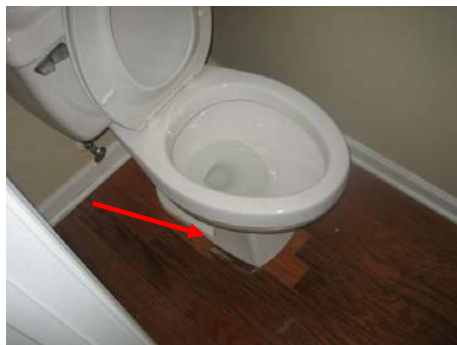
The toilet bowl in the First Floor Half Bathroom is loose at the floor (SEE PHOTO). Recommend securing bowl to floor and flange and installation of a new wax ring if deemed necessary by a qualified plumber,

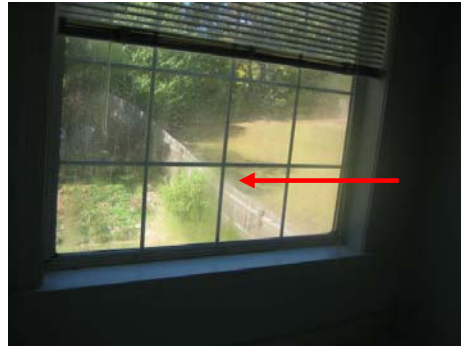
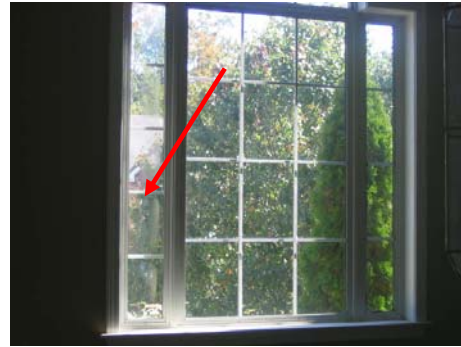
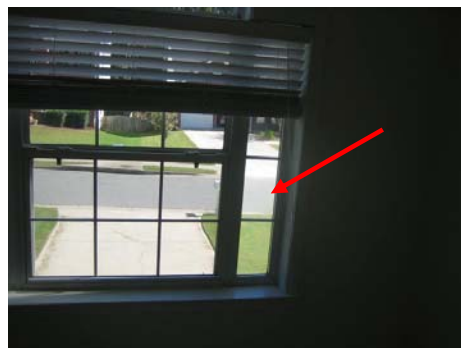
Cloudiness and condensation noted at the window in the Master Bathroom above the tub and at the sidelight windows above the front entrance and at the east wall of the Master Bedroom (SEE PHOTOS). This condition is the result of a leak at the seal between the two thermal panes of glass. Cloudiness will persist and likely worsen over time. It is a condition that cannot be repaired in a practical manner. Recommend replacement of cloudy windows.

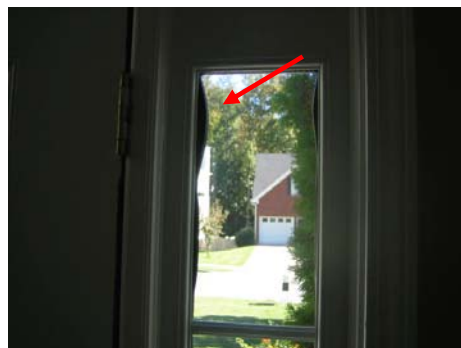
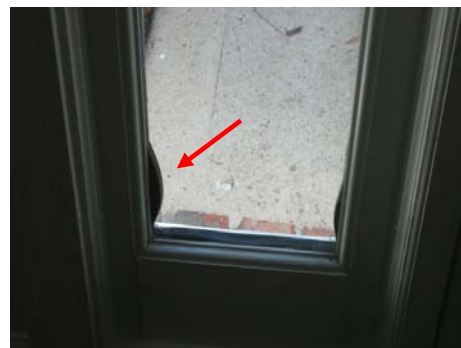
Deformed spacer seals are noted at the sidelight windows at the front entrance (SEE PHOTOS). This condition is the result of a manufacturing defect that causes the seals to expand when exposed to the heat of the sun. Recommend replacement of sidelights at front entrance.

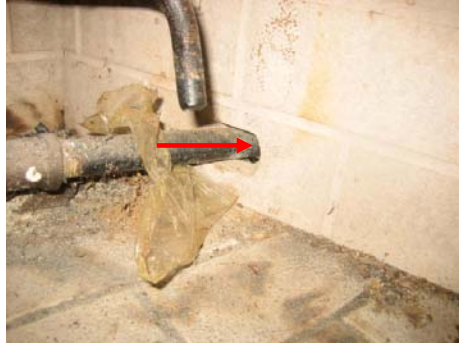
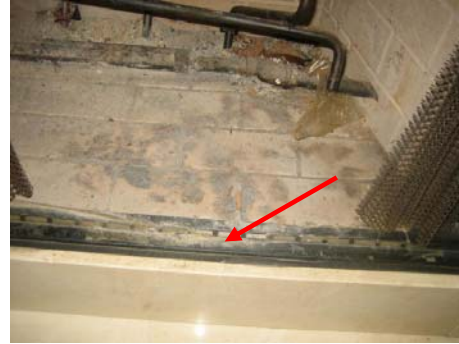
A gap is noted at the firebrick panel in the fireplace where the gas line passes through the wall (SEE PHOTO). This condition may allow excessive heat and flames to draft through the opening and come into contact with flammable material. It should also be noted that the homeowner has applied plastic tape over the openings at the front of the hearth that are intended to assist the combustion process (SEE PHOTO). Recommend sealing gap with an appropriate caulk product where gas line passes through firebrick panel and removal of plastic tape at fireplace.

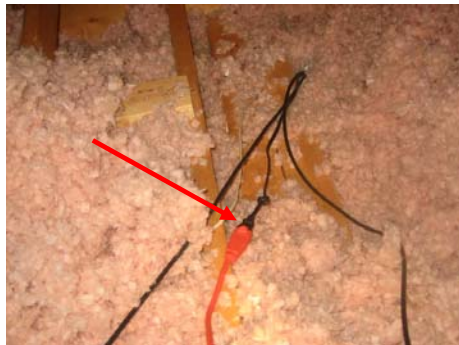
Extension cord wiring is noted in the Attic, serving a wall-mounted TV in the Second Floor South Bedroom (SEE PHOTO). Extension cords are not intended as a permanent circuit and could potentially become a fire hazard. Recommend removal of extension cord wiring in Attic.

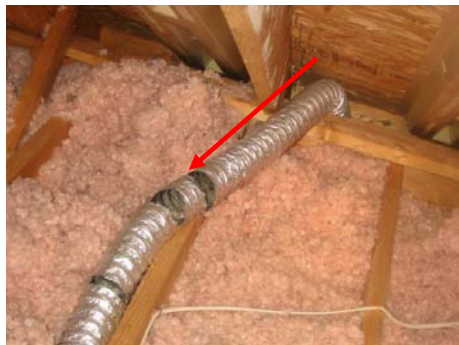
A duct in the Attic serving the Second Floor Hallway Bathroom exhaust vent has several holes that appear to be the result of a rodent (SEE PHOTO). Recommend replacement of damaged exhaust vent duct in Attic and evaluation and treatment if necessary by a qualified pest control technician.

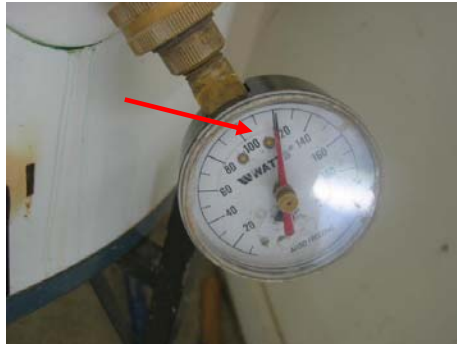
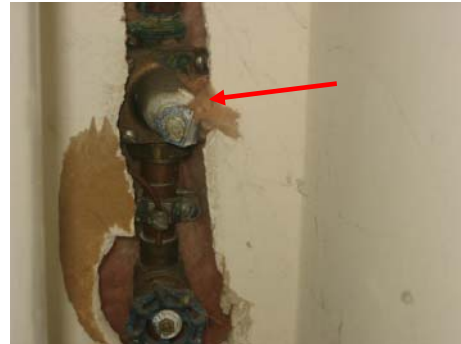
The water pressure inside the home is very high, measuring 120 psi (SEE PHOTO). Typical indoor water pressure is 40-60 psi. A level above 80 psi may cause damage to pipes and fixtures. The cause for the high water pressure is a poorly adjusted or failed water pressure regulator (SEE PHOTO). Recommend adjustment or replacement of water pressure regulator, as deemed necessary by a qualified plumber.

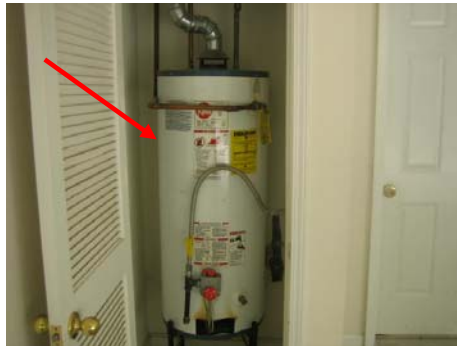
The water heater is 12 years old and therefore approaching the end of its expected service life (SEE PHOTO). It's likely the water heater will need replacement within the next five years.

FYI: The typical expected service life for water heaters similar to this unit is about 12-15 years.

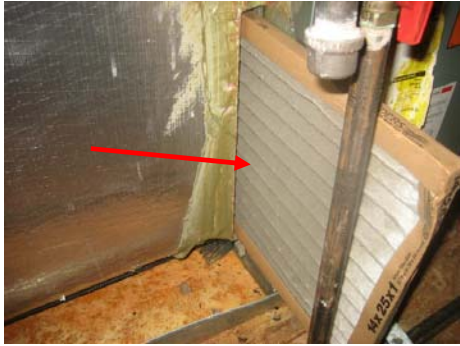
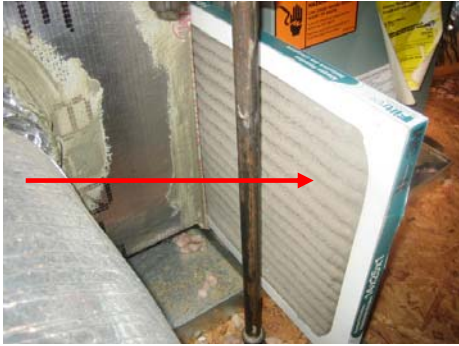
Dirty filters are noted at both HVAC units (SEE PHOTOS). Recommend replacement of filters.

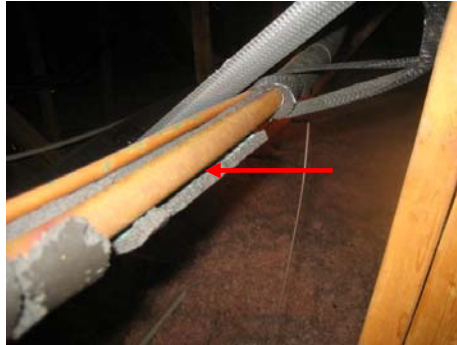
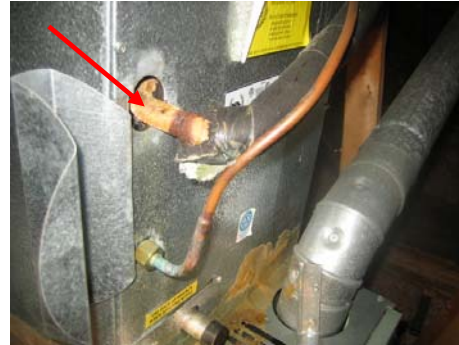
Insulation is noted missing in several locations on both air conditioning refrigerant lines in the Attic and where they enter the HVAC units (SEE PHOTOS). This condition will allow condensation to form on the exposed copper refrigerant line, which will result in ceiling stains and possible mechanical damage where moisture falls into the HVAC units. Recommend installation of sleeved insulation on all areas of exposed copper refrigerant lines in the Attic.

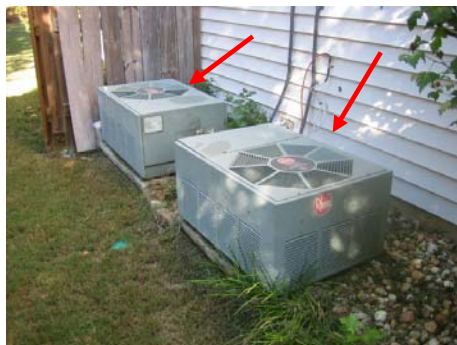
Both air conditioning systems are operating satisfactorily at present but at 12 years old they are approaching the end of their expected service life (SEE PHOTO). It is likely both air conditioning systems will need replacement within the next five years. Recommend regular HVAC maintenance to help prolong the useful service life of the heating and air systems.

FYI: The typical expected service life of air conditioning systems similar to the one in this home is about 15 years.
